## Five-Year Review Report

Industrial Excess Landfill (IEL)  
Uniontown, Ohio

May 2011

**United States Environmental Protection Agency  
Region 5  
Chicago, Illinois**

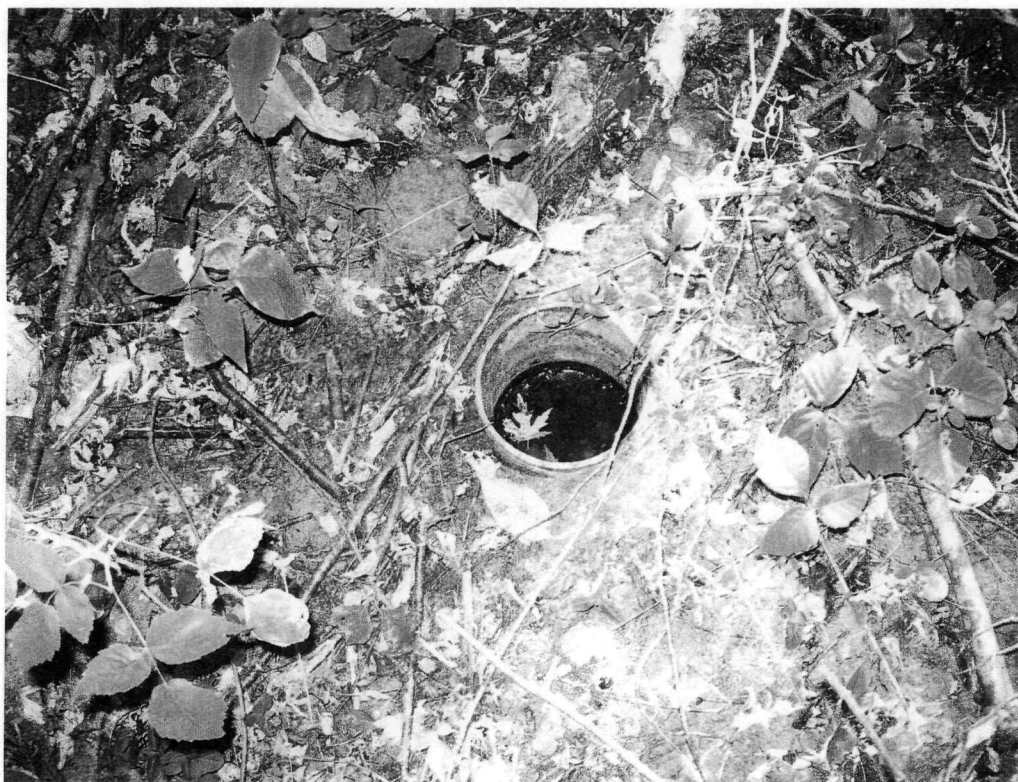
The monitoring wells at the site were generally in good repair, although there were some instances in which maintenance is needed. An unlabelled landfill gas monitoring well in the central portion of the eastern side of the site was found to have loose casing. A landfill gas well in the central portion of the northern side of the site was found to be open with cracked casing. A well on the northeast side of the property had heaved. Groundwater monitoring wells 7d and 7i had casing that was rusted and open. Finally, an unidentified open pipe coming out the ground was found on the northeast side of the site (see photo in Attachment 8).

3.	<b>Monitoring Wells (within surface area of landfill)</b>	Functioning	Routinely sampled	Good condition
	Properly secured/locked		<u>Needs Maintenance</u>	<u>N/A</u>
	Evidence of leakage at penetration			
	Remarks <u>There <del>is</del> are open pipes sticking out of the ground on NE sides of site (see photograph). Wells 7d, 7i casing rusted open.</u>

1. Open pipe at northeast portion of IEL site.

A more comprehensive and complete inspection of the monitoring wells at the site should be performed, with the appropriate follow-up maintenance. The gate and fencing should be repaired, and trash found at the Site should be removed. Vegetation at the site should be managed so that it does not interfere with the integrity of the perimeter fence.

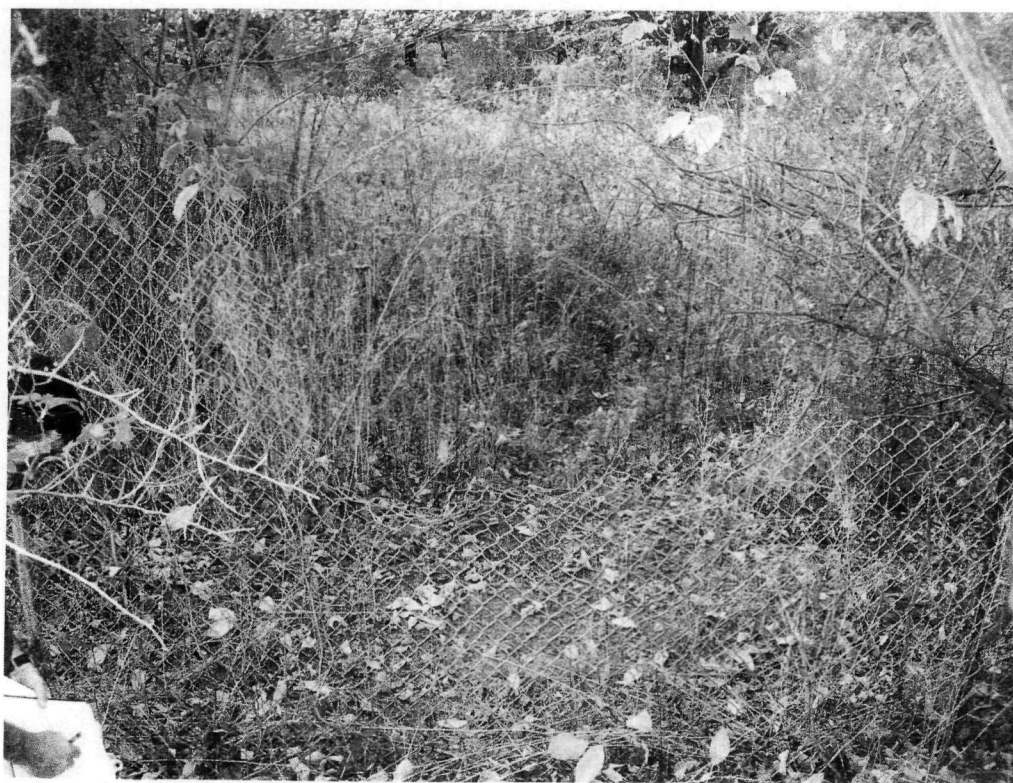
Site security is maintained through the use of perimeter fencing. Some sections of the fencing need maintenance or repair, but there is no indication that the damage has resulted in an unacceptable risk to site trespassers. Maintenance of the site property grounds are needed to address the debris which litters the site.

Remarks Found beer can + hose on EPA property North of the center of the site. Found breaches in site perimeter fence.

2. Breach of fence at site perimeter

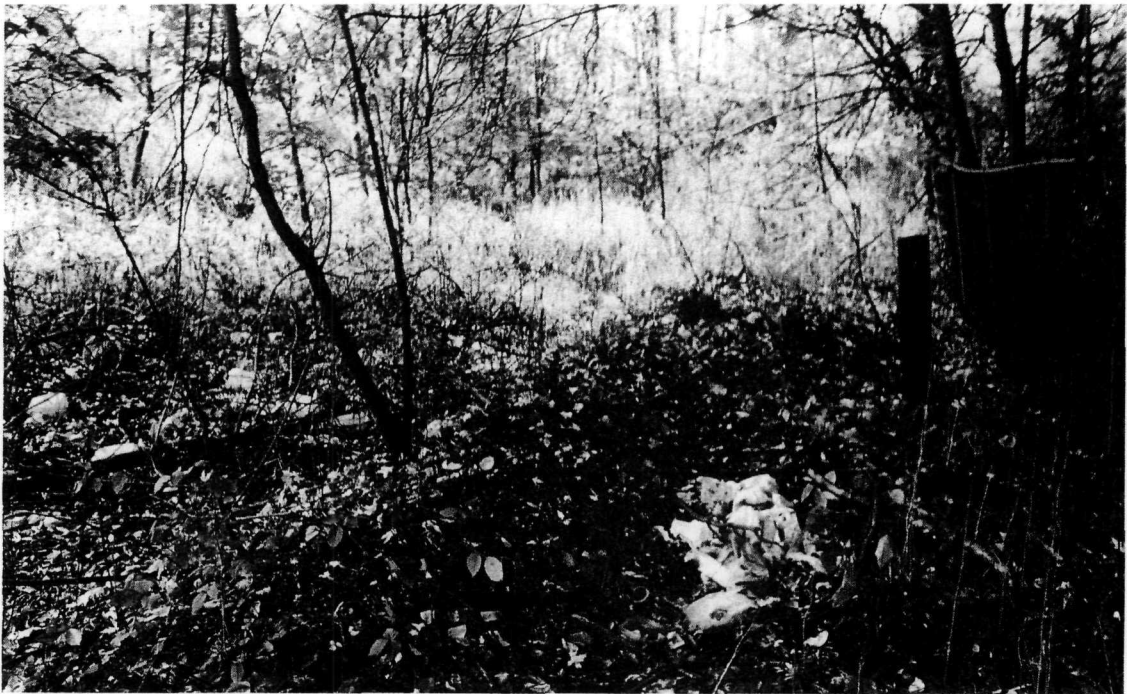
Found lots of trash on W side of property, near Cleveland Ave.

3. Trash dumped over fence at western border of IEL site

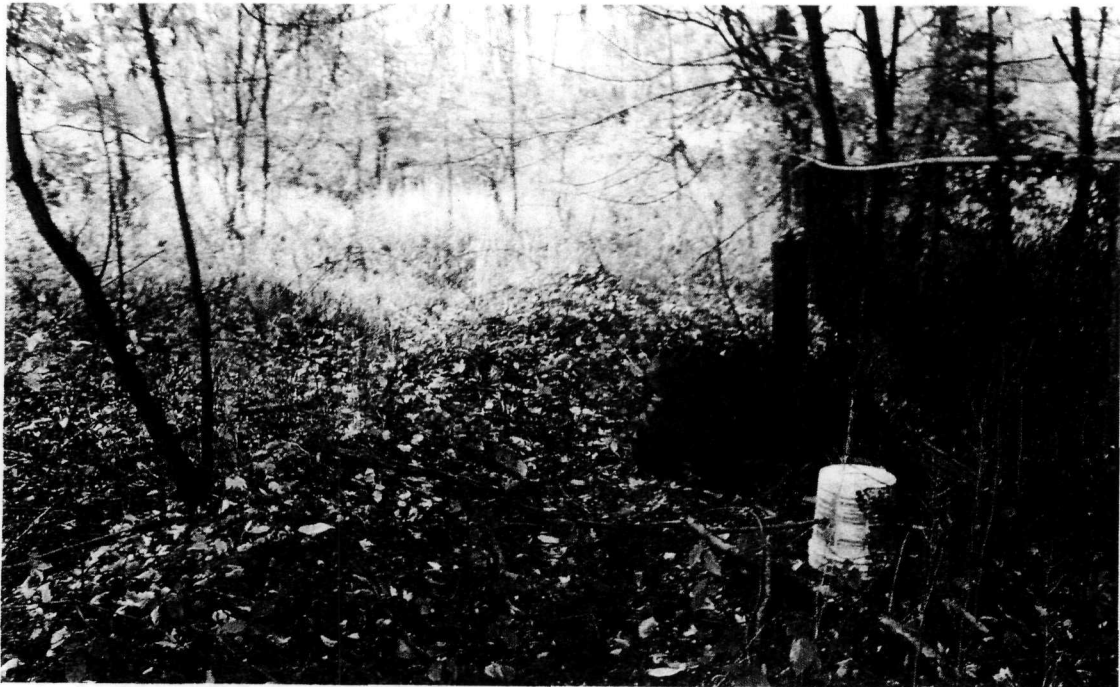
4. Bagged trash dumped over fence at IEL site.
